TECHNICAL MEMORANDUM

SUBJECT: Site visit report

SITE: DTG-Anderson Landfill

DATE: January 20, 2023

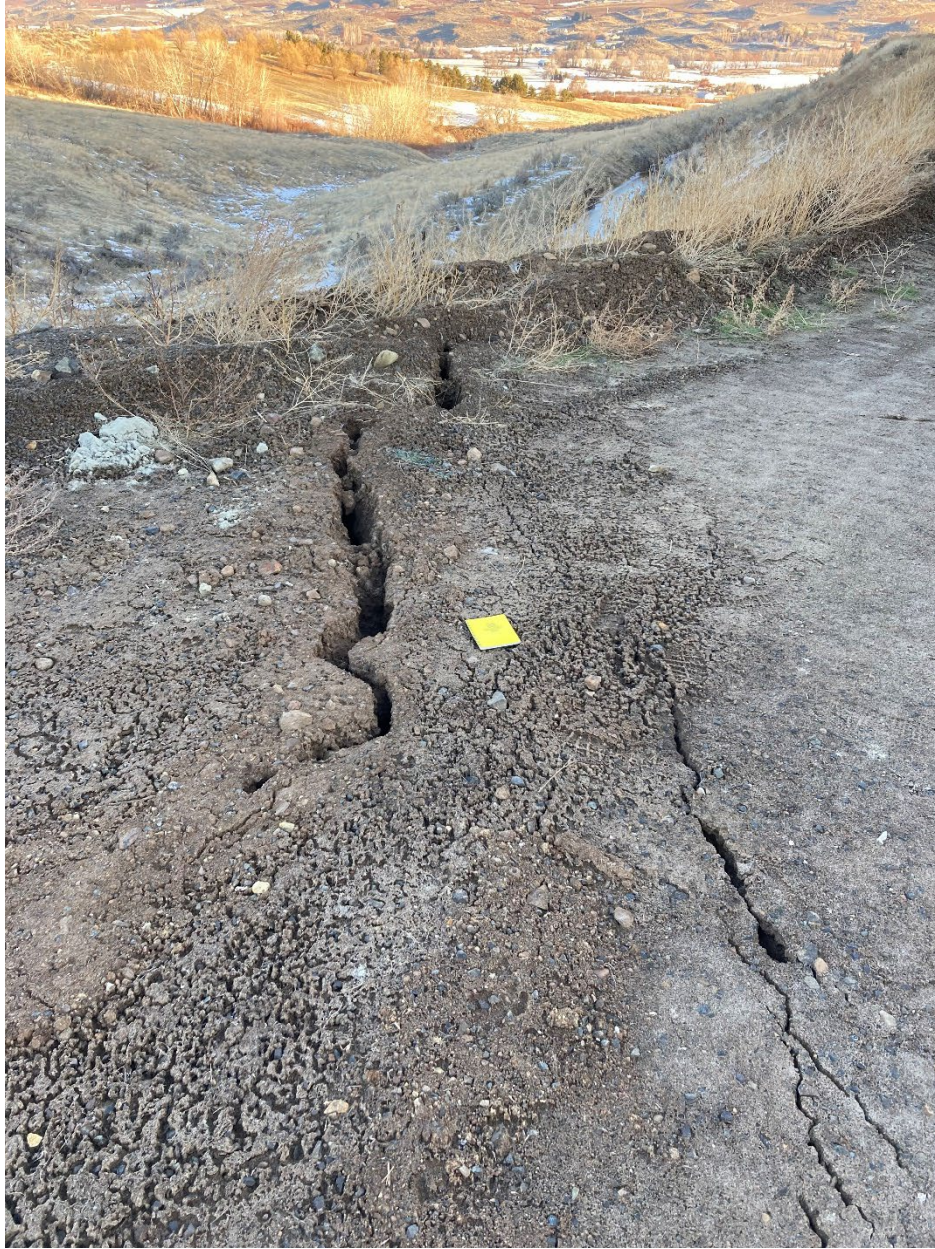
After walking the draw, I walked the lower road on the northwest flank of the landfill. The soil in this area was not frozen, in contrast to all the soil along the quarry haul road and in the draw. Numerous cracks were observed in and adjacent to the road (Figures 4 and 5). Cracks in the road have been observed in this area before, but they are now significantly larger than in the past. Areas of green vegetation and warm thermal signatures were observed adjacent to the road as well (Figures 5 and 6).

Figure 4: Cracks on perimeter landfill road.

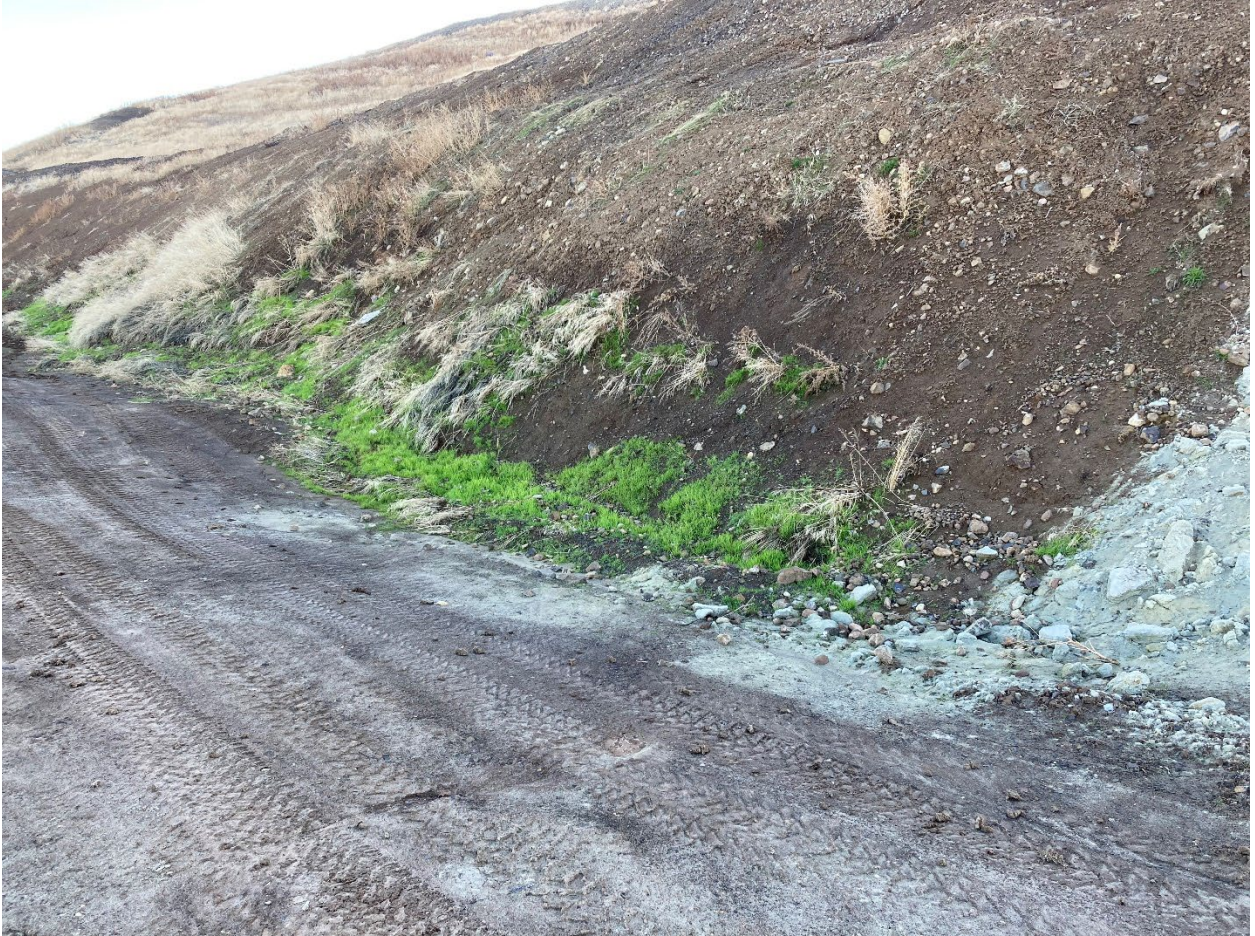
Figure 6: Close-up view of green vegetation along perimeter road.

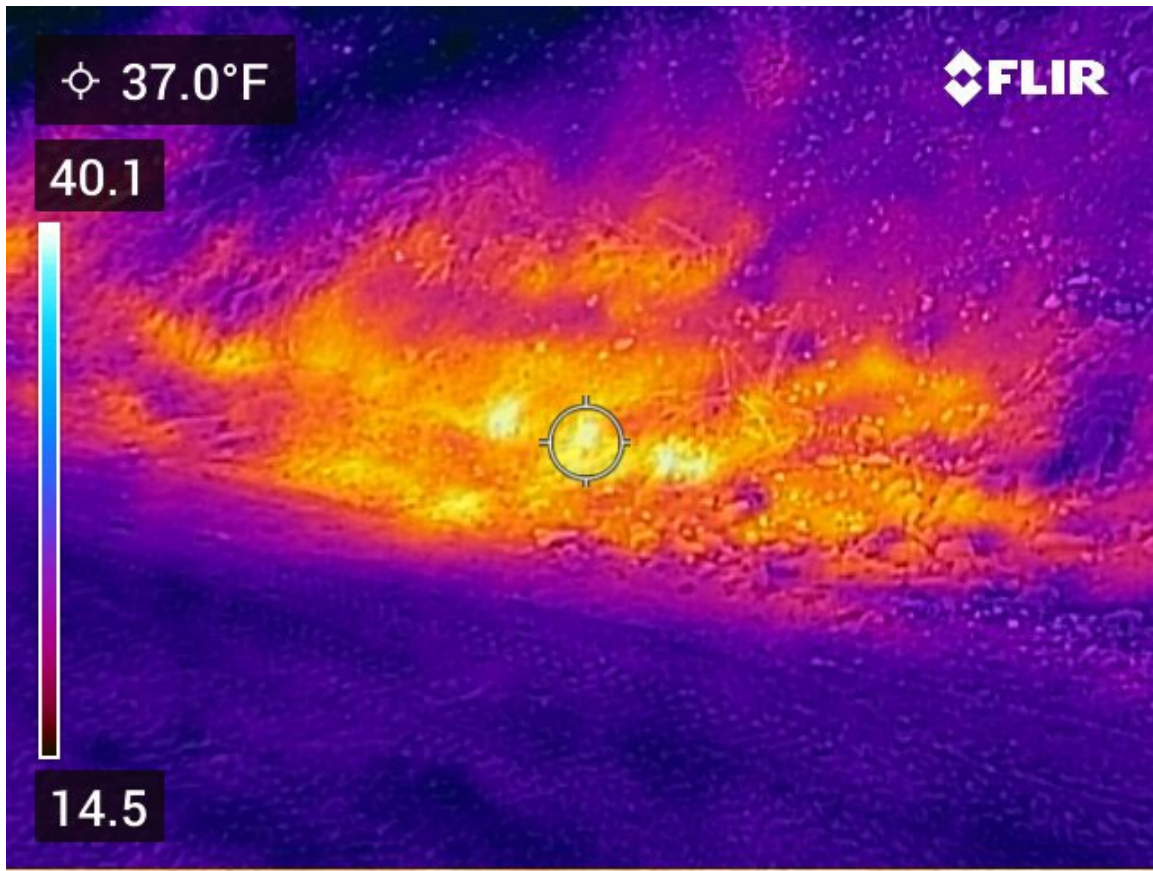
Temperature of the soil in the area of green vegetation was approximately 25F warmer than the road adjacent to it (Figure 7). Odors were noticeable in this area.

Figure 7: Thermal scan of green area from Figure 4.

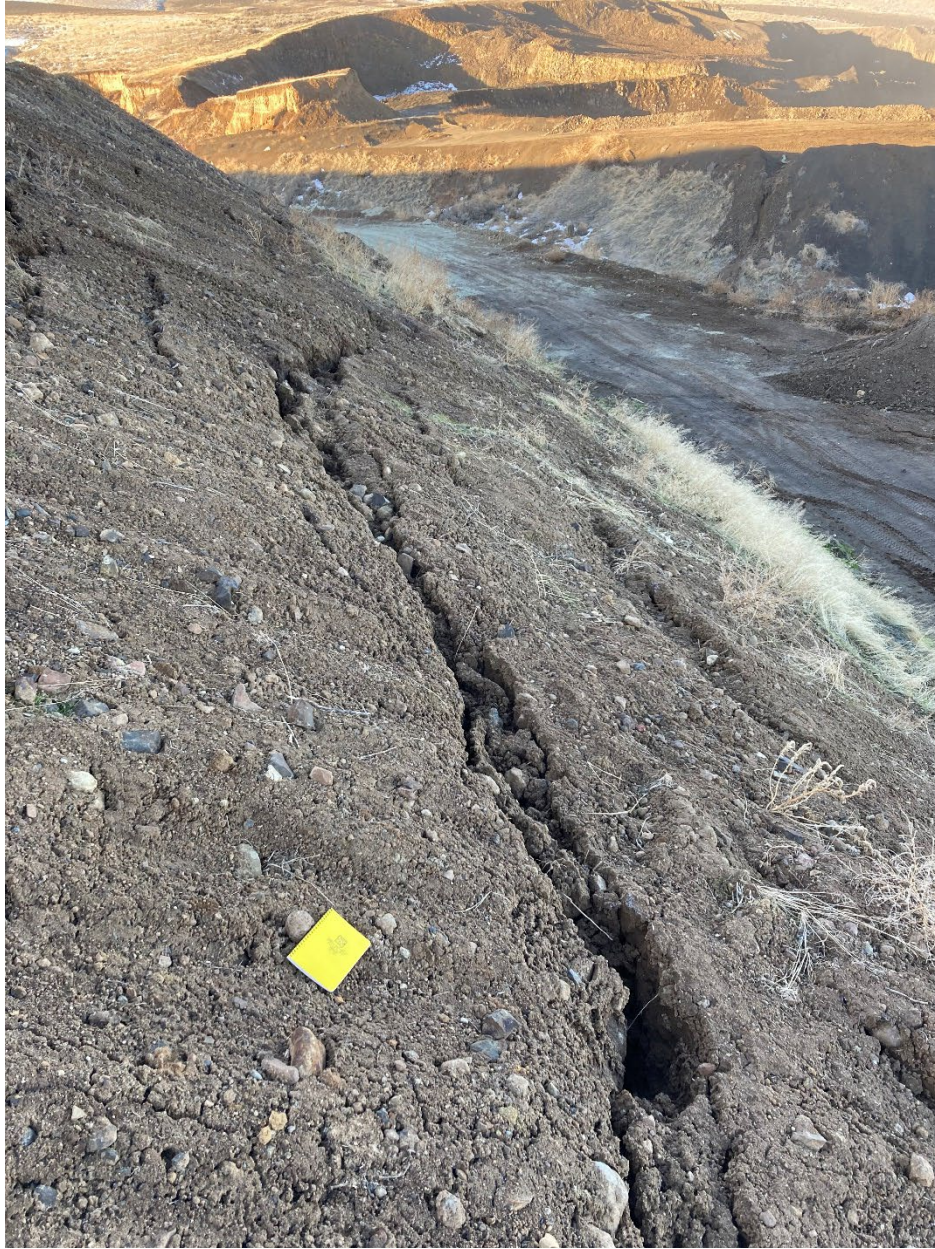
After following the cracks for a few hundred feet past the previously documented hot-spot, the cracks ended and I walked up the slope to the upper road. Numerous large cracks were observed in the flank of the landfill between the two roads running roughly parallel to the contours of the slope (Figure 8). Odors were strong in this area. Roughly directly upslope from the green vegetation noted earlier was a series of fine cracks with black residue around them producing smoke/vapor and very strong odor (Figures 9 and 10). Thermal images of these cracks indicate temperature of roughly 90F, approximately 73F warmer than the surrounding soil (Figure 11).

Figure 8: Cracks in slope above perimeter access road. Green vegetation directly below.

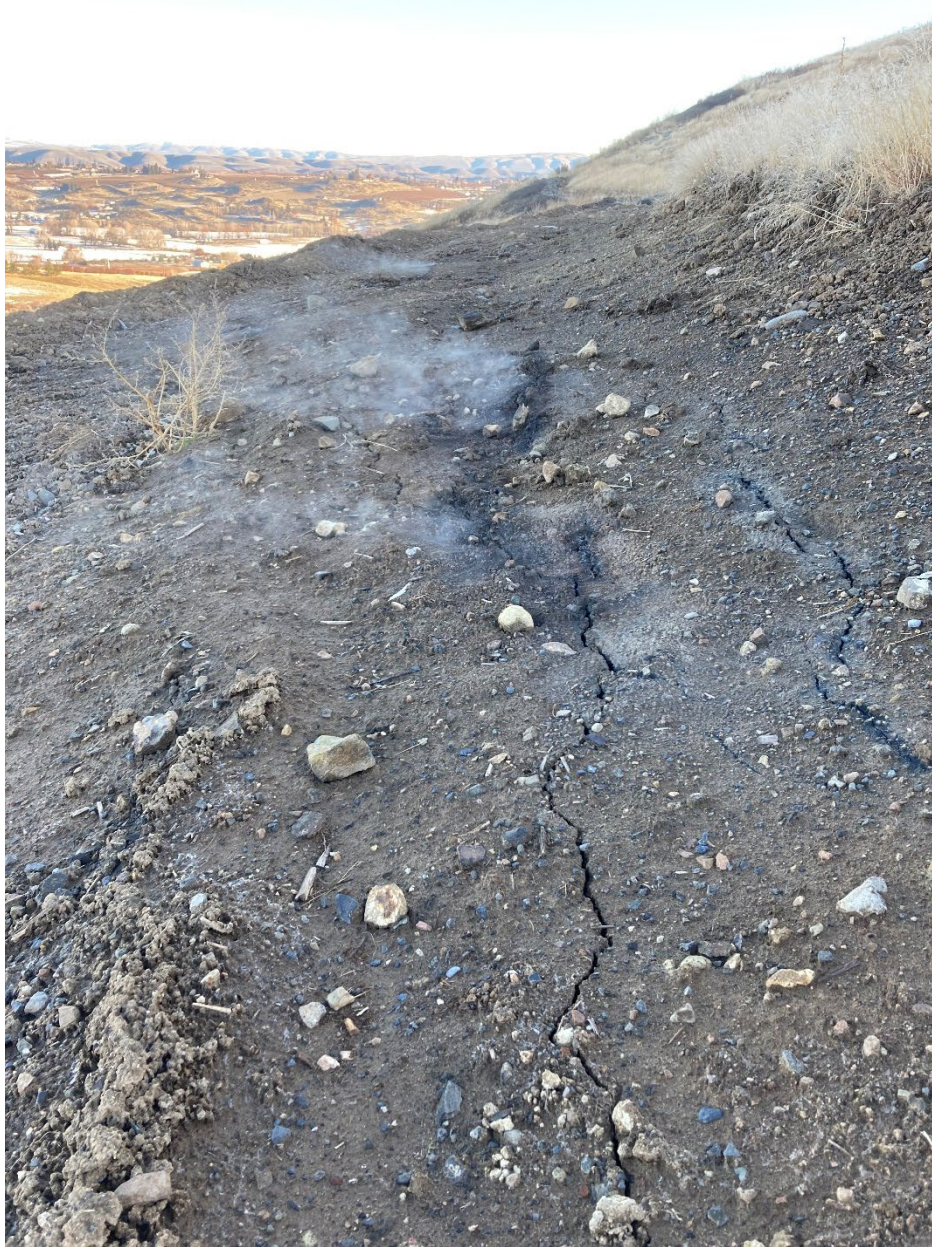
Figure 10: Facing north. Fine cracks in upper road above repaired slope with black residue around cracks and smoke/vapor emanating from cracks.

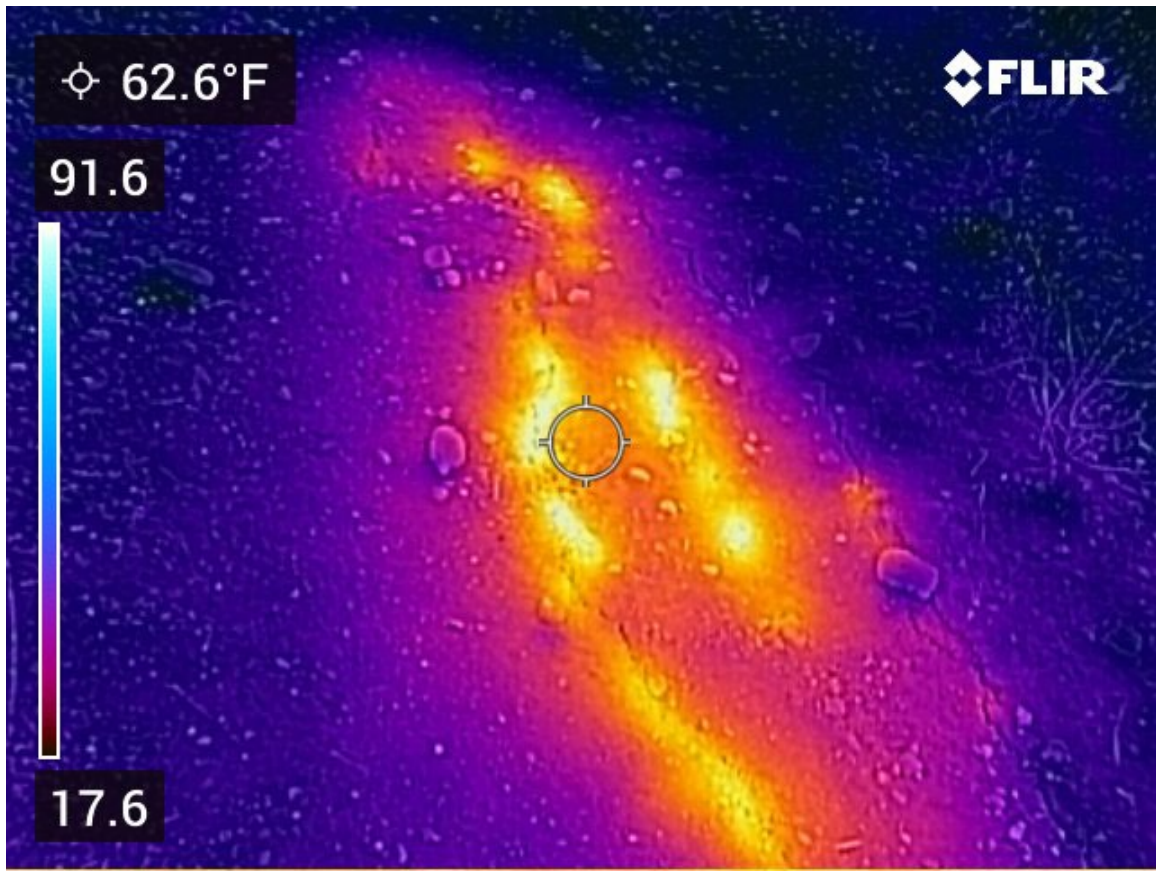
We have previously suspected a subsurface fire in this area, but indications at the time were somewhat ambiguous. Observations from January 19, 2023, collectively indicate ongoing combustion beneath the surface.

Figure 11: Thermal scan of cracks on upper road.
