## Comments on Tech Note 23 Assessments for Yakima County 2015 to 2021

Friends of Toppenish Creek - August 1, 2021

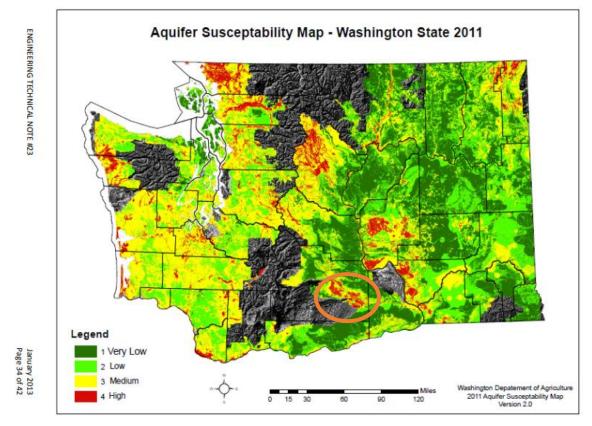
1. This is the WSDA Map that the agencies use for determining Aquifer Susceptibility to pollution from lagoons<sup>2</sup>.

Much of the Lower Yakima Valley falls into the "High" category. But none of the dairies in this study had an aquifer susceptibility score greater than 3 - Medium. (See Columns U & BF) This indicates a tendency to downplay problems associated with manure lagoons.
