STATE OF WASHINGTON
DEPARTMENT OF ECOLOGY

Re: Further Action at the following Site:

- **Site Name:** The Ostrom Farms
- **Site Address:** 8322 Steilacoom Road SE
- **Facility/Site No.:** 1386
- **Cleanup Site ID No.:** 5033
- **VCP Project No.:** SW1283

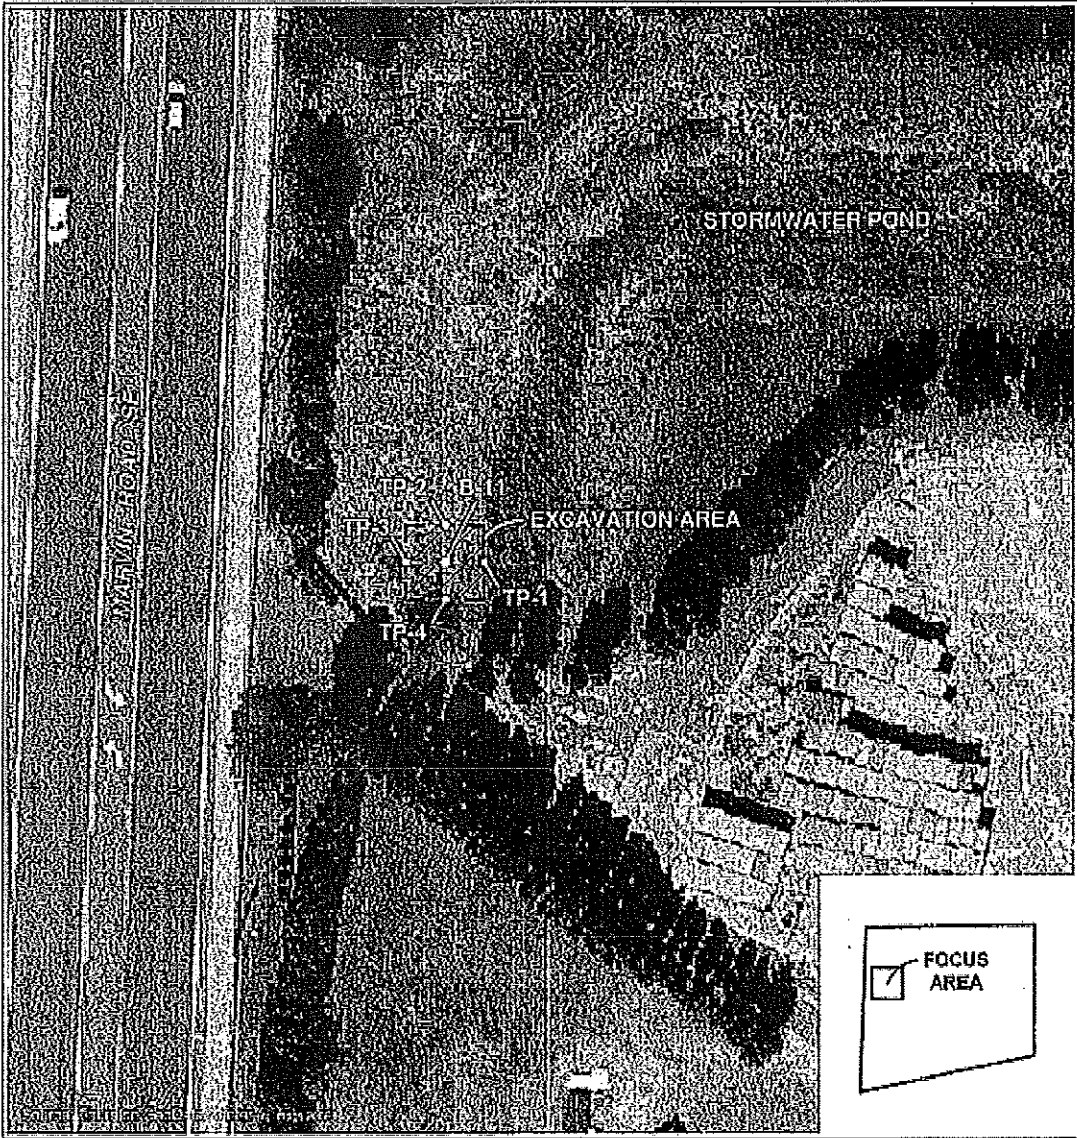
Figure 2
Site Plan

- An unknown amount of soil was excavated in June 2012 from an area around borehole B-11, which was drilled and sampled during June 2007 Site investigation. The area was excavated to the depth of 6 to 9 feet bgs. The soil excavated appeared to be fill, containing a large percentage of trash, including oil filters, tires, bits of metals, glass, and bricks.

- Four confirmation soil samples (TP1 through TP4) were collected from the four walls of the excavation pit at 8 – 9 feet bgs. All samples were non-detect for TPH-Gx, TPH-Dx, mineral oil-range TPH, and oil-range TPH.

Figure 2. The Location of the Soil Excavation at Ostrom Farm in June 2012

1. The June 2007 Site investigation detected TPH-Dx and heavy oil-range TPH at boreholes B6 and B12. The soil excavation, however, was conducted around borehole B-11. Cleanup is still warranted in the vicinity of borings B6 and B12.
2. The confirmation soil samples were only from sidewalls. Ecology requires that a bottom soil sample(s) also be collected.
