WA Dairies Near Rivers & Streams

This is a summary description of dairies in Washington State that are near rivers and streams, as determined by a review of *County Maps with Dairy Locations from 2018 WSDA Agricultural Land Use with Dairies - ARC GIS Hub.*

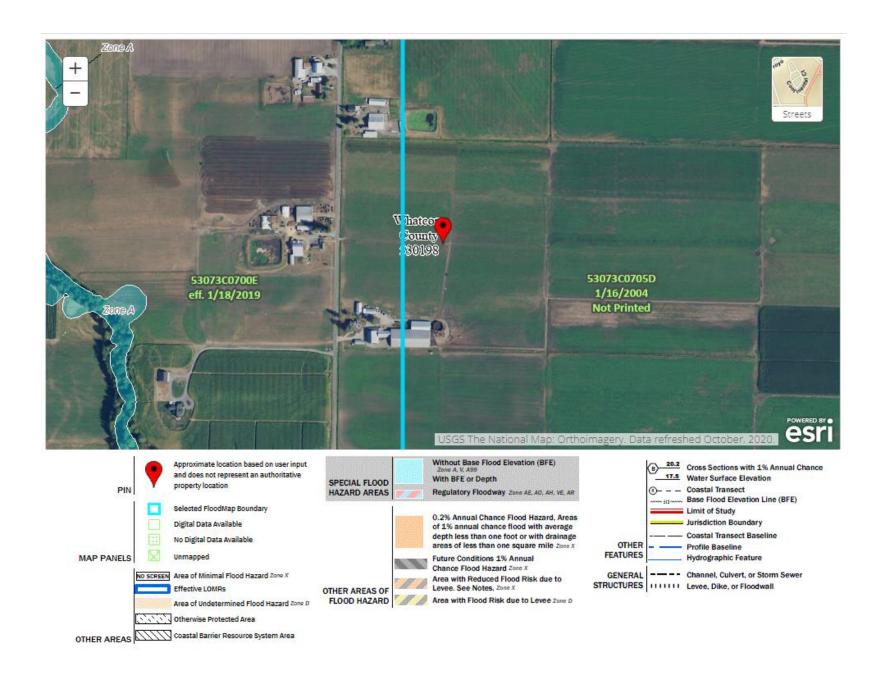
Fresh Breeze Organic Dairy

\approx 1,100 feet from lagoon to Bertrand Creek

Depth to Water Table: 80 cm

Drainage Class: Somewhat Poorly Drained

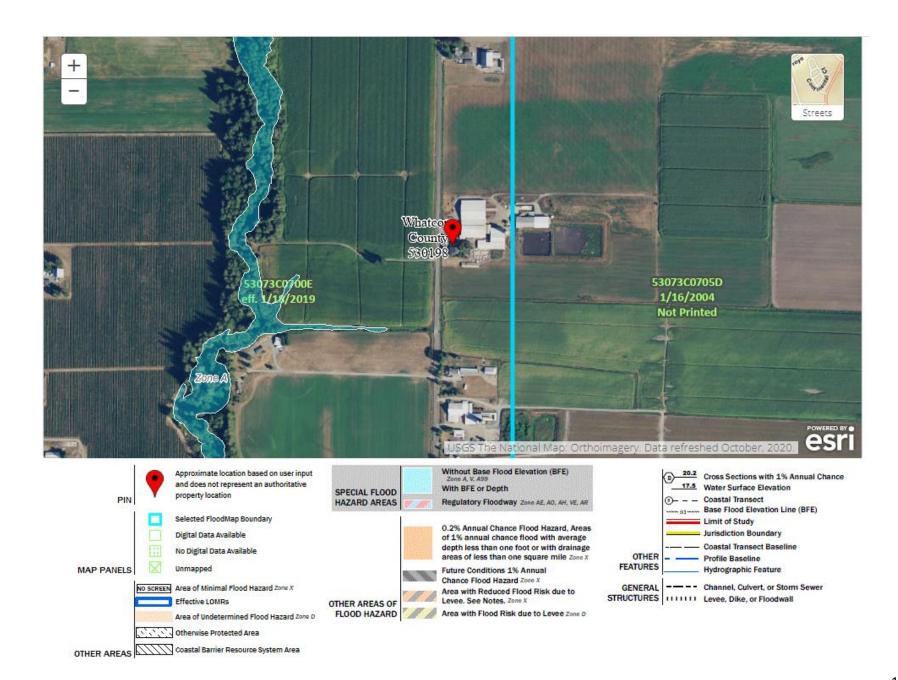
Van der Haak Farm

\approx 1,800 feet from Lagoon to Bertrand Creek

Depth to Water Table: 80 - 90 cm

Drainage Class: Somewhat Poorly Drained

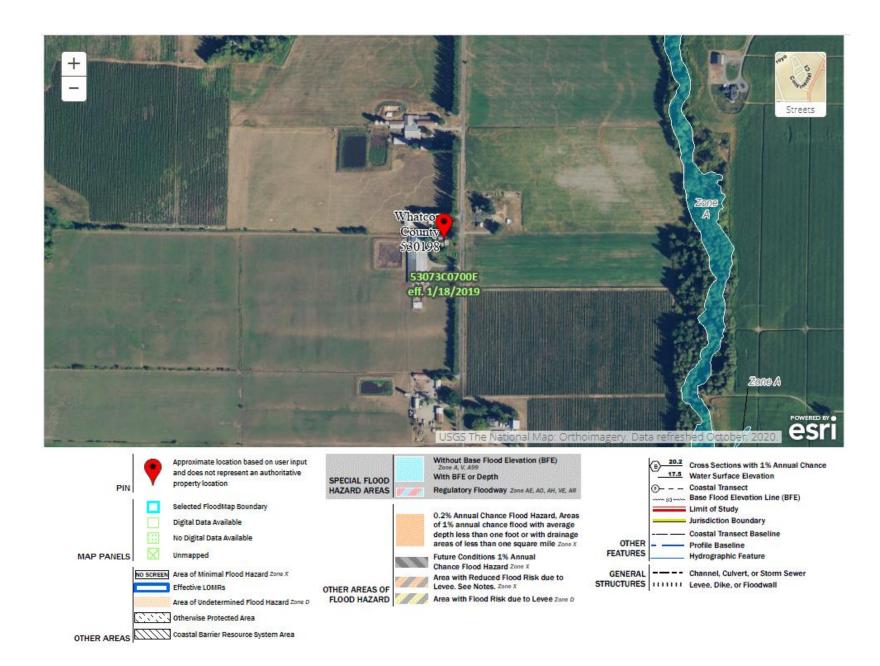
Steensma Dairy

\approx 1,800 feet from lagoon to Bertrand Creek

Depth to Water Table: 80 cm

Drainage Class: Somewhat Poorly Drained

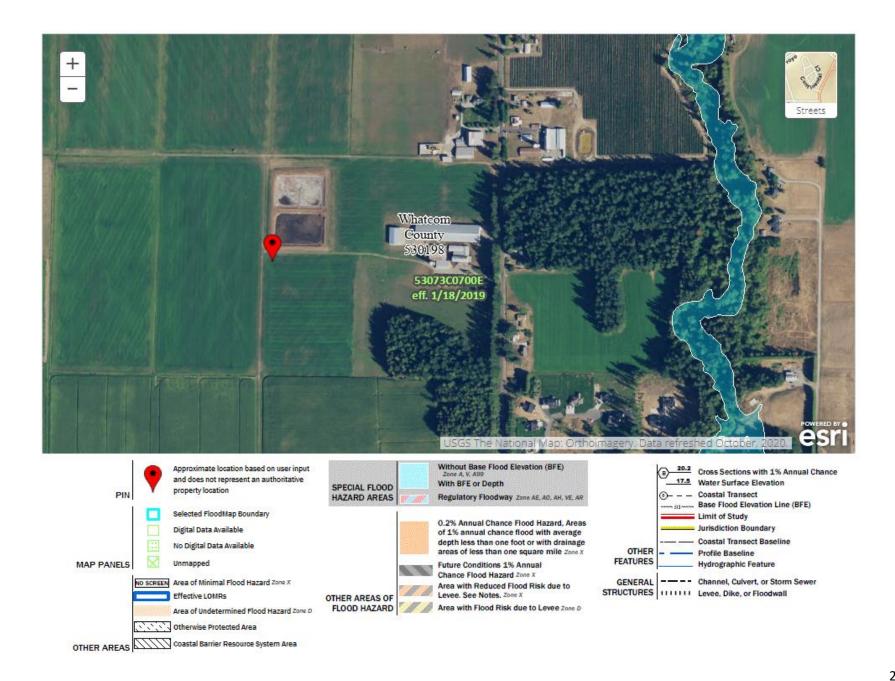
Cedar Park Dairy LLC

\approx 2,200 feet from lagoons to Bertrand Creek

Depth to Water Table: 80 - 92 cm

Drainage Class: Somewhat Poorly Drained

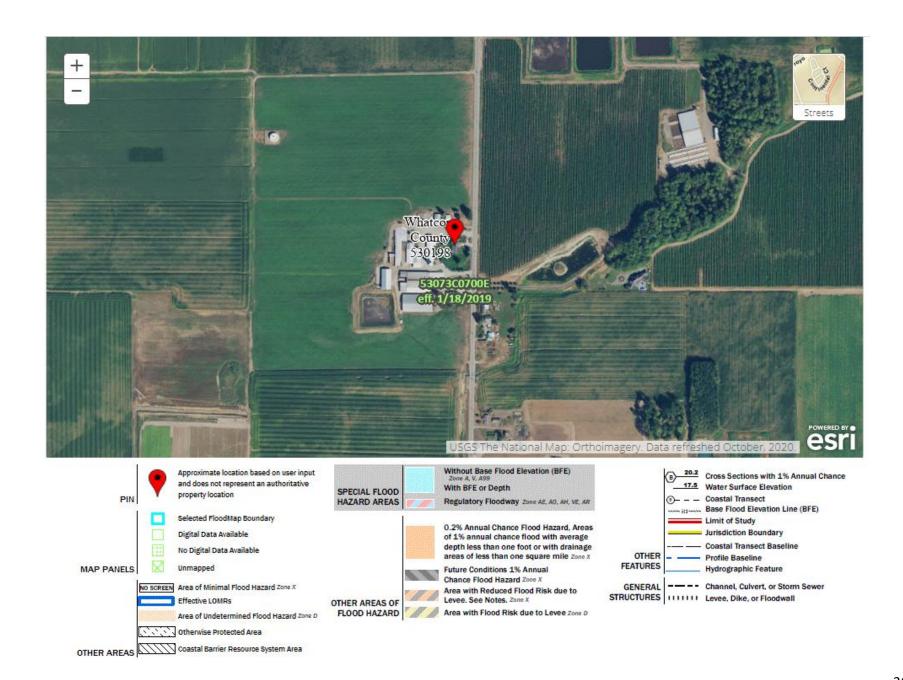
James Dairy

8305 N Enterprise Rd, Custer WA \approx 1,500 feet from lagoon to South Fork Dakota Creek

Depth to Water Table: 61 - 62 cm

Drainage Class: Somewhat Poorly Drained/Moderately Well Drained

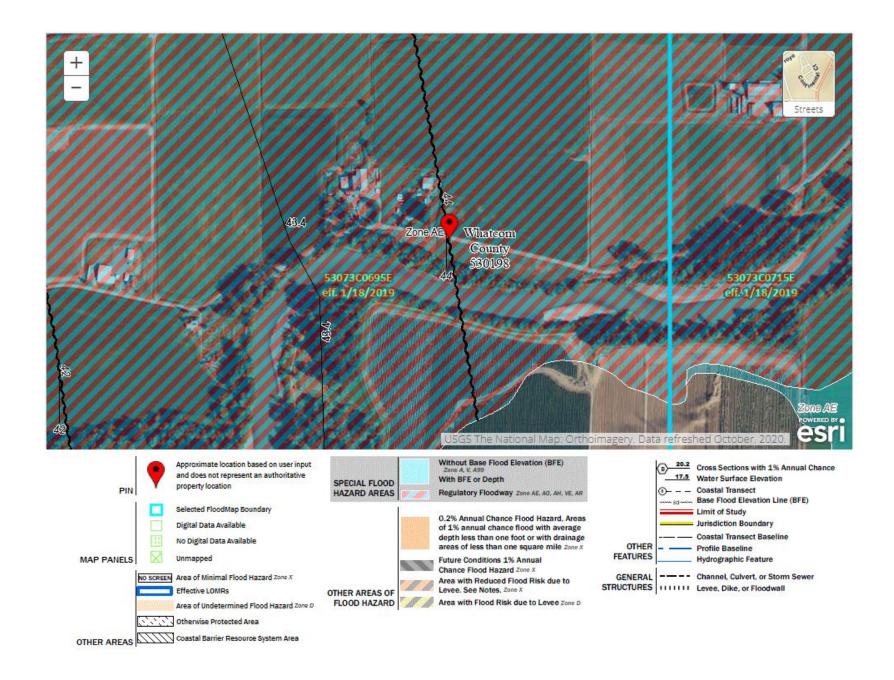
Dickinson Farms

517 River Road, Lynden WA \approx 450 feet from lagoon to Nooksack River, in flood plain

Depth to Water Table: > 200 cm

Drainage Class: Well Drained

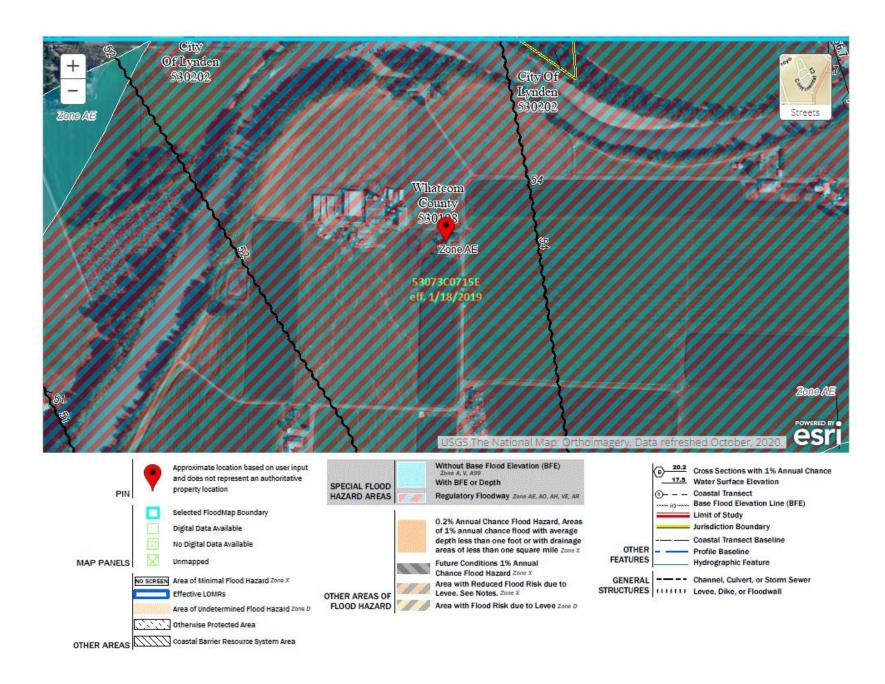
Riverside Dairy

\approx 200 feet from the lagoon to the river, in flood plain

Depth to Water Table: 92 cm

Drainage Class: Moderately Well Drained

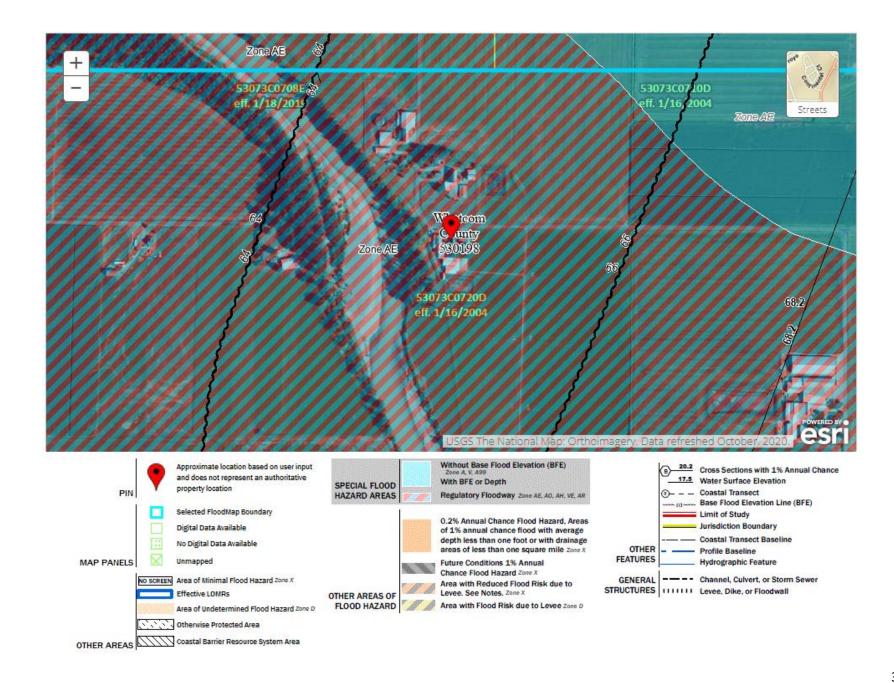
Edelweiss Dairy

1519 Timon Road, Everson WA \approx 200 feet from the lagoon to the Nooksack River, in flood plain

Depth to Water Table: $> 200 \ cm$

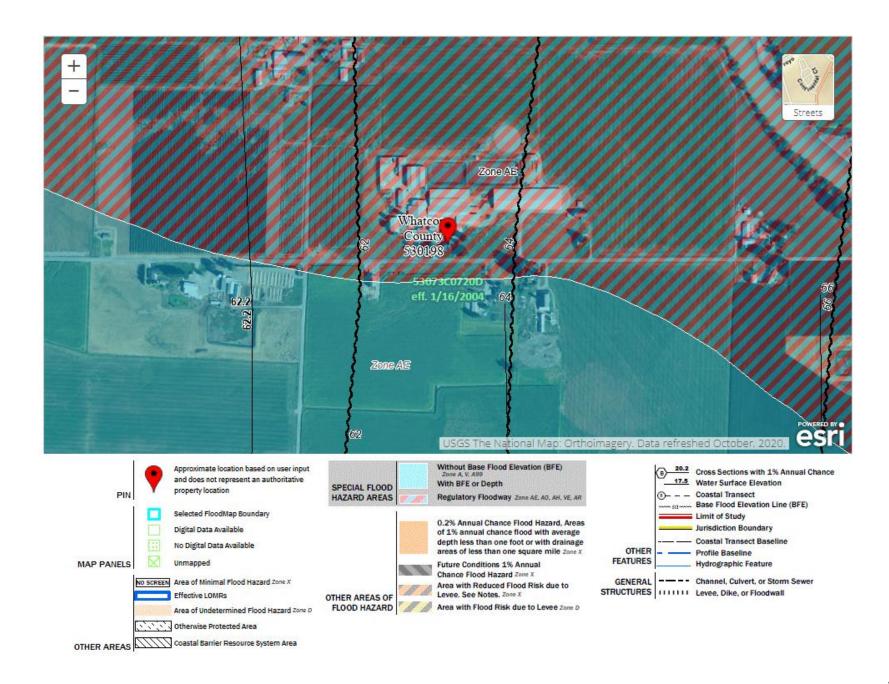
Eagle Mill Farms and DJ Noon Challenge

1364 Abbott Road, Lynden WA \approx 1,400 feet from the lagoons to the Nooksack River, in flood plain

Depth to Water Table: 92 cm

Drainage Class: Moderately Well Drained

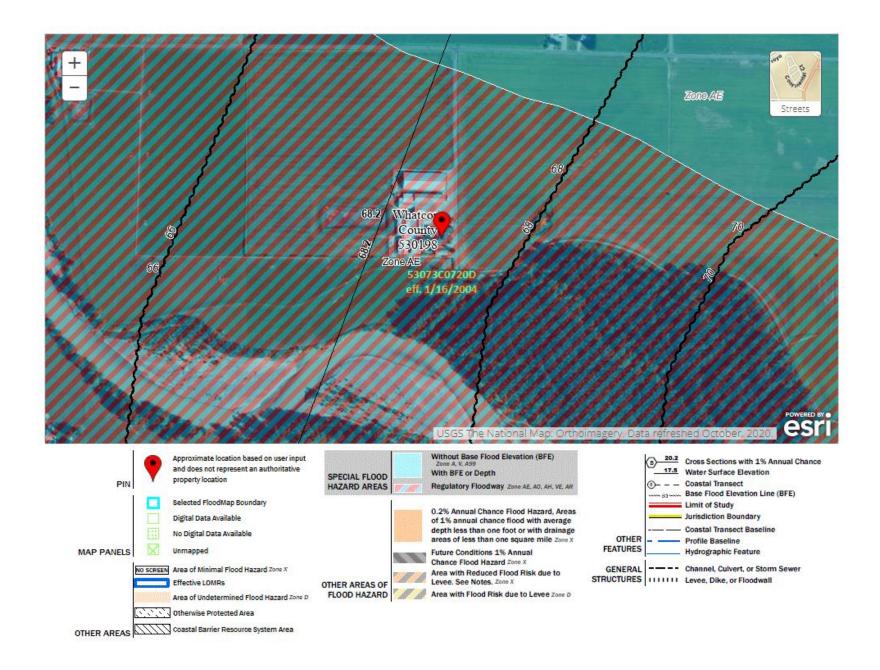
Van Berkum & Sons Dairy

≈ 350 feet from the lagoons to the Nooksack River, in flood plain

Depth to Water Table: 60 cm

Drainage Class: Poorly Drained

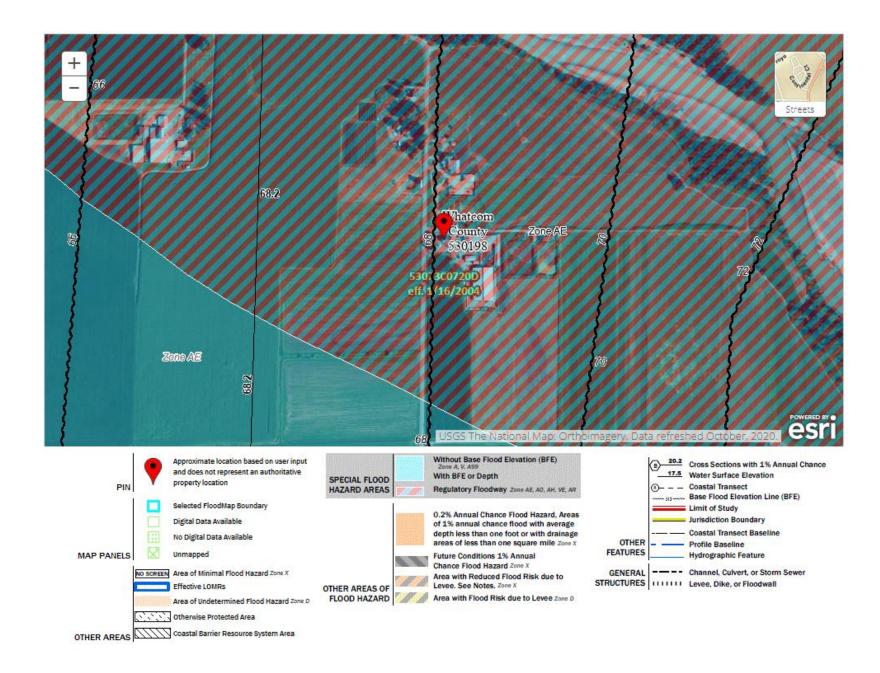
Noteboom Farm LLC

\approx 2,400 feet from the lagoons to the Nooksack River, in flood plain

Depth to Water Table: 60 cm

Drainage Class: Poorly Drained

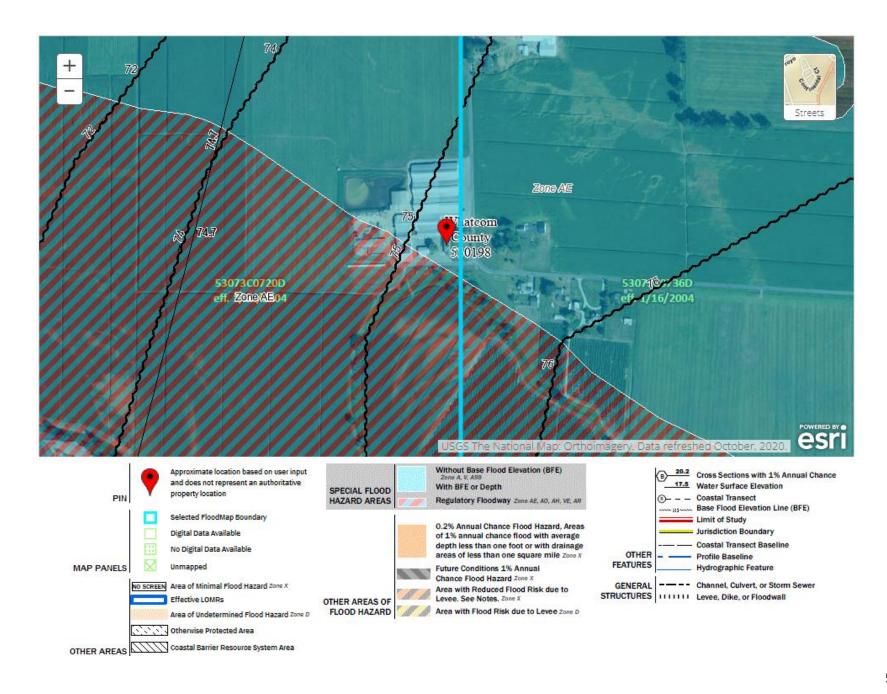
Vande Hoef Dairy LLC

\approx 1,600 feet from the lagoon to the Nooksack River, partially in flood plain

Depth to Water Table: $> 200 \ cm$

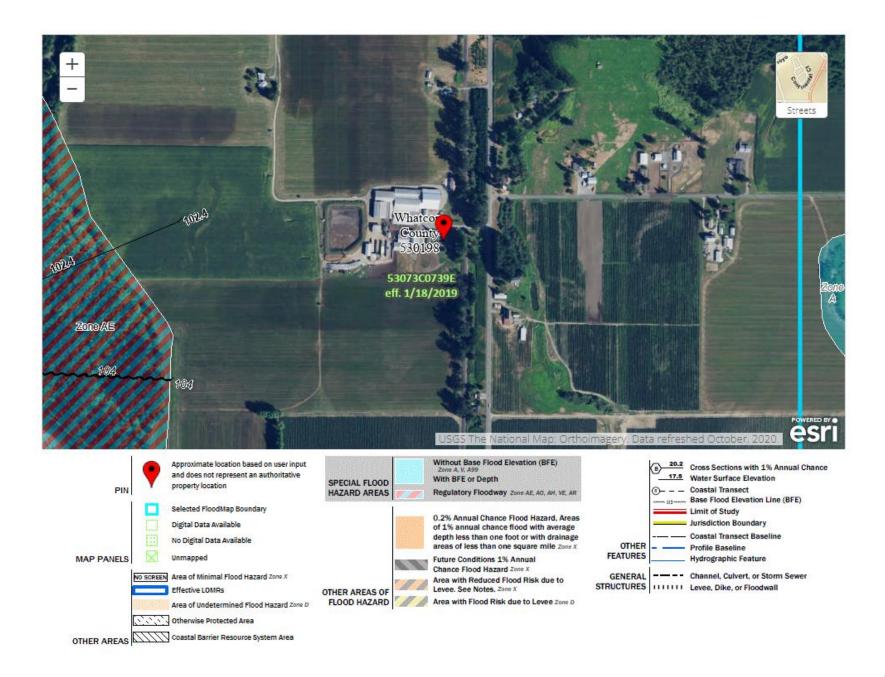
Van Dellen Farms LLC

\approx 2,500 feet from the lagoon to the Nooksack River

Depth to Water Table: 92 cm

Drainage Class: Moderately Well Drained

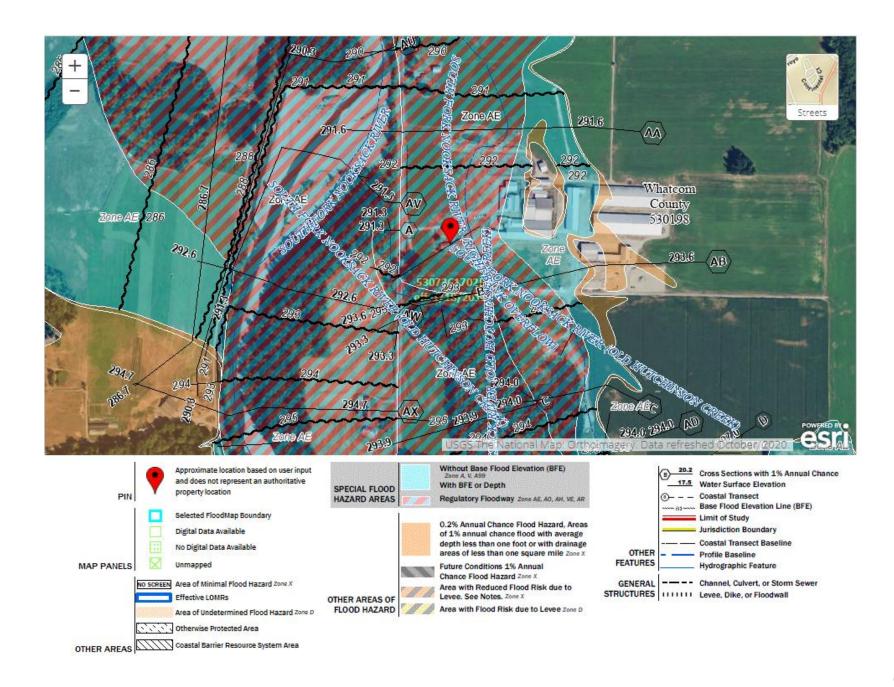
Coldstream Farms LLC

\approx 1,400 feet from the lagoons to the Nooksack River, in flood plain

Depth to Water Table: $> 200 \ cm$

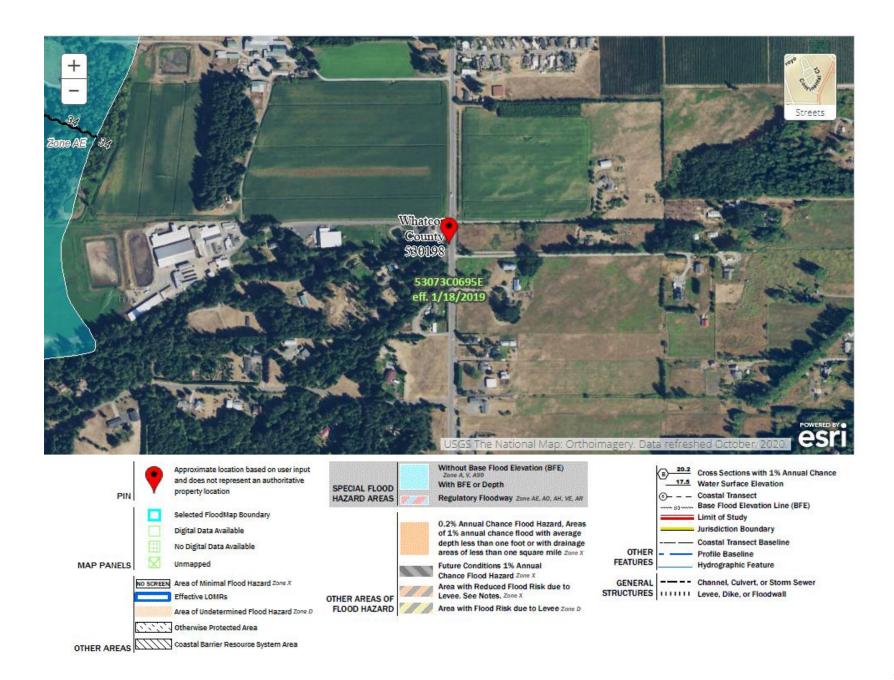
Appel Brothers Dairy

\approx 2,200 feet from lagoon to Nooksack River

Depth to Water Table: $> 200 \ cm$

Drainage Class: Moderately Well Drained

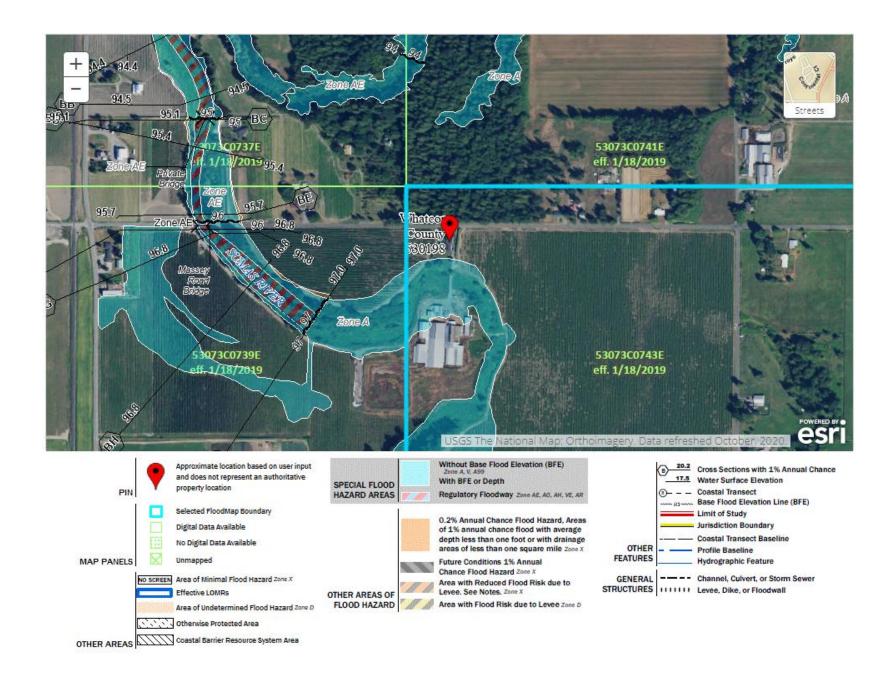
Mendoza Dairy

\approx 200 feet from lagoon to the Sumas River

Depth to Water Table: 60 - 92 cm

Drainage Class: Poorly Drained/Moderately Well Drained

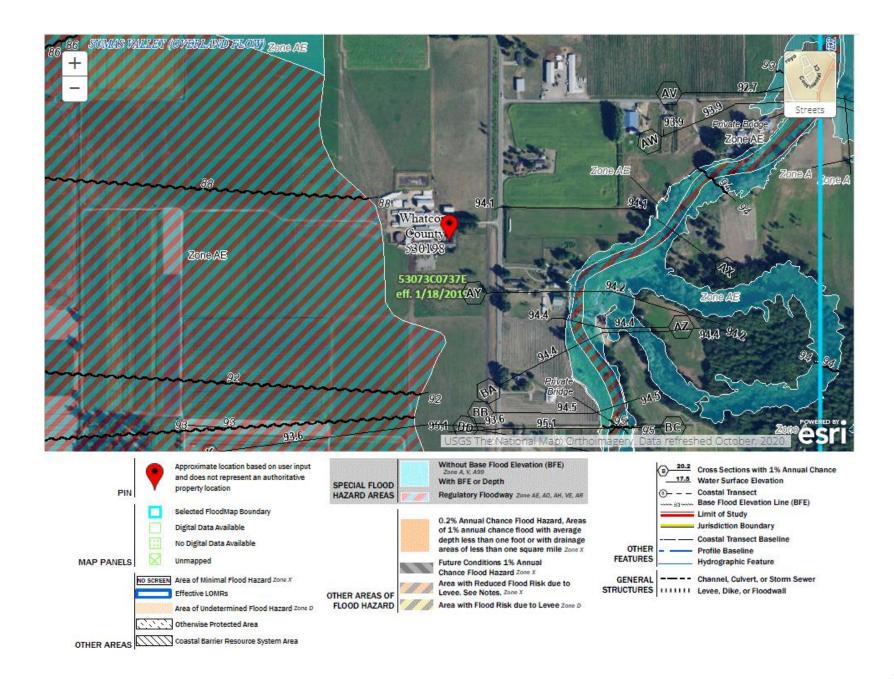
Hopewell Farms

\approx 1,200 feet from the lagoon to the Sumas River

Depth to Water Table: 60 cm

Drainage Class: Poorly Drained

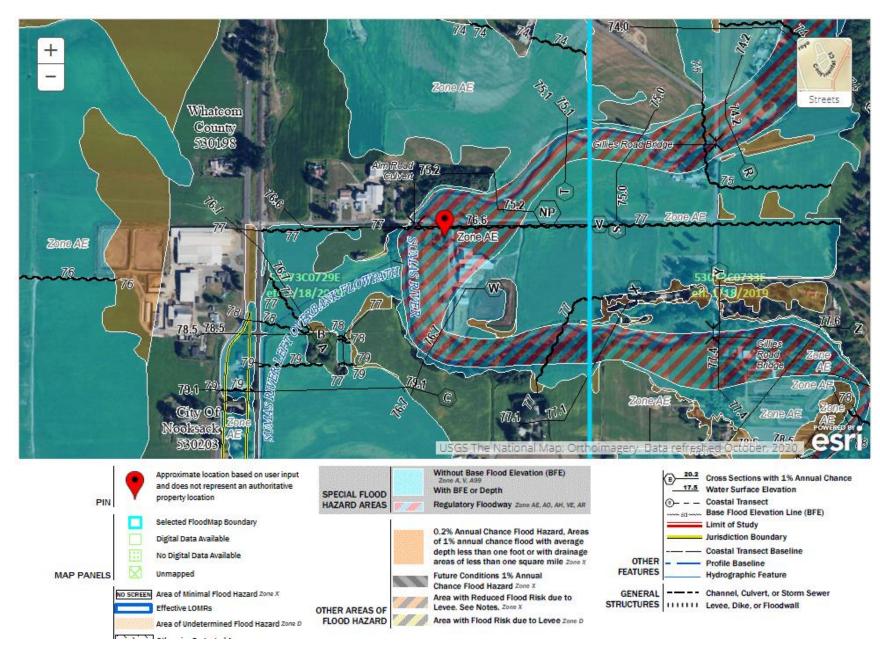
Pete de Jager Dairy

≈ 200 feet from the lagoon to the Sumas River, in flood zone

Depth to Water Table: 92 cm

Drainage Class: Moderately Well Drained

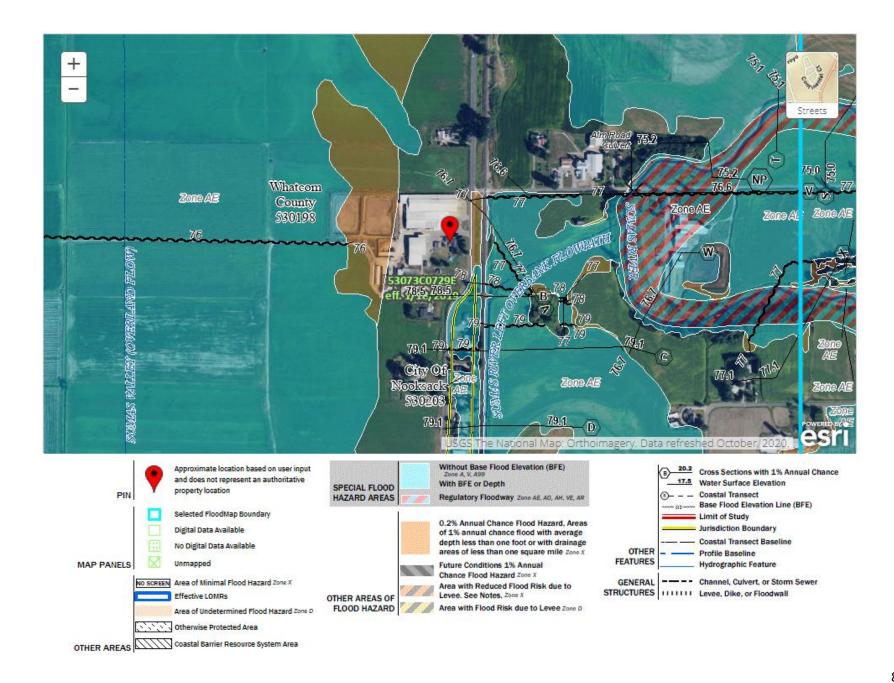
Udder Pride Dairy

\approx 1,400 feet from the lagoons to the Sumas River

Depth to Water Table: 92 cm

Drainage Class: Moderately Well Drained

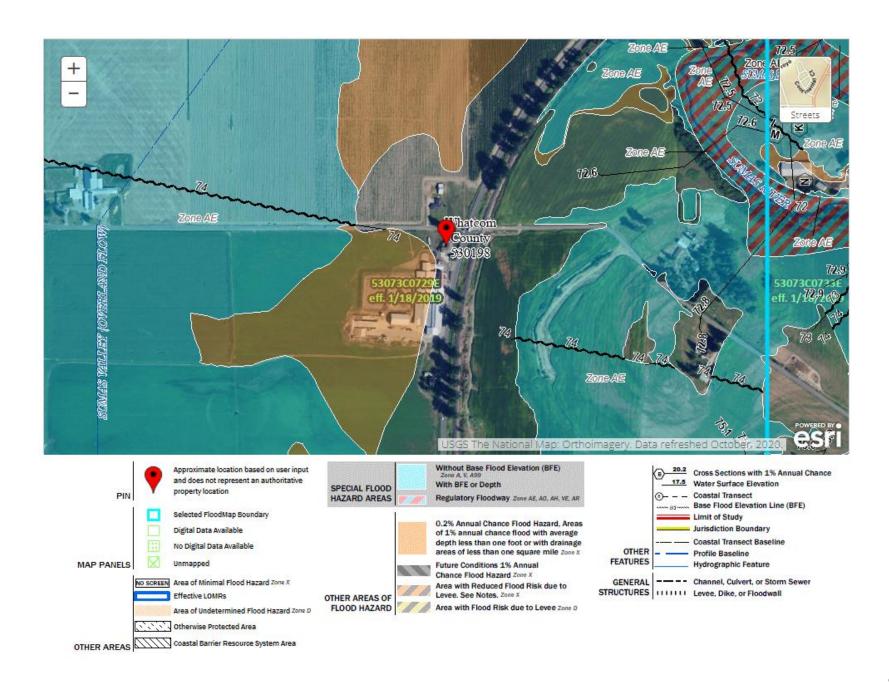
TC Berkum Farm

\approx 2,100 feet from the lagoons to the Sumas River

Depth to Water Table: 92 cm

Drainage Class: Moderately Well Drained

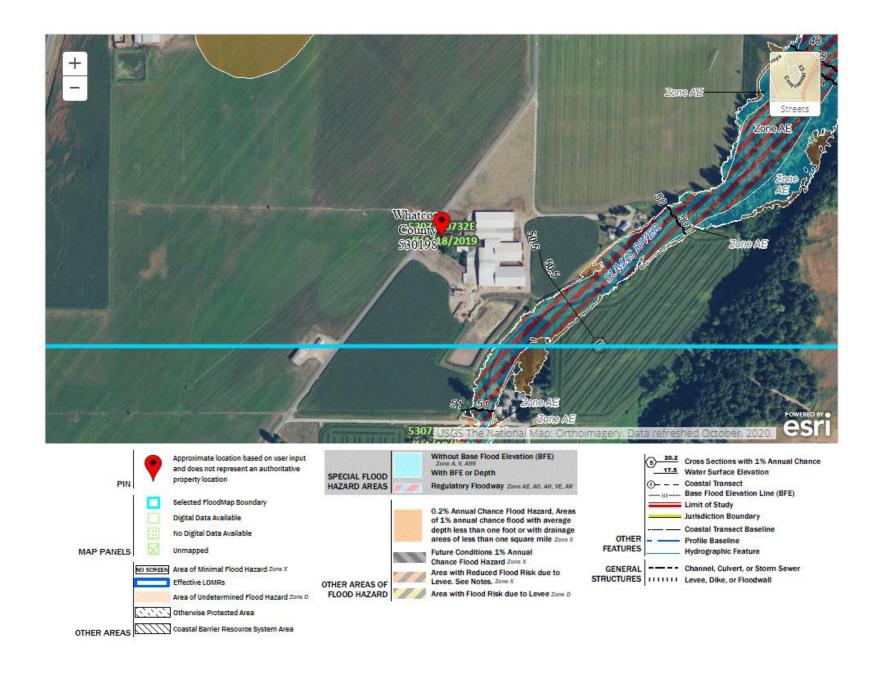
JV Dairy LLC

≈ 100 feet from the lagoon to the Sumas River

Depth to Water Table: 60 - 91 cm

Drainage Class: Moderately Well Drained/Poorly Drained

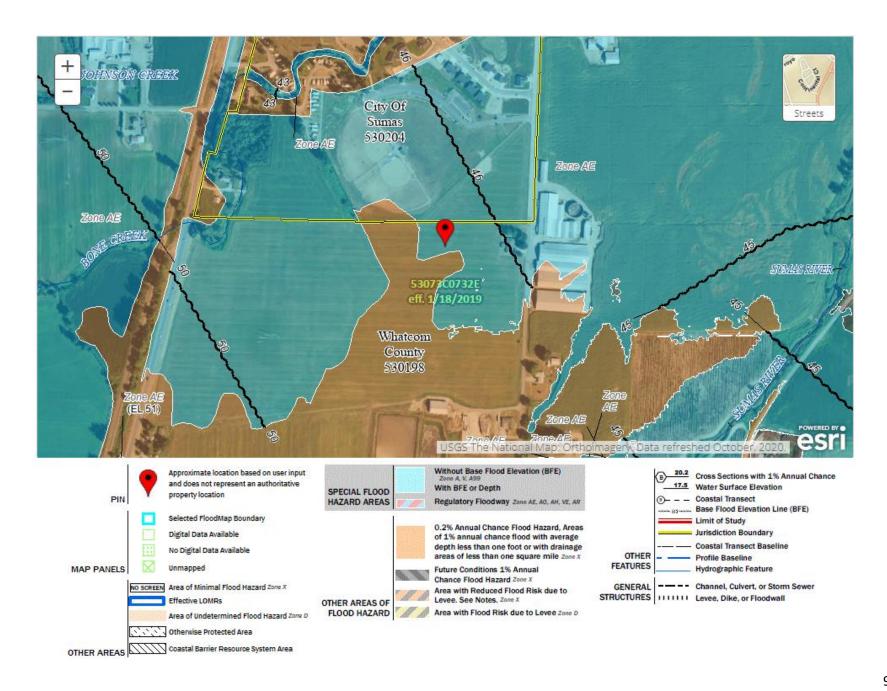
Maarhuis Dairy LLC

≈ 700 feet from the lagoons to the Sumas River

Depth to Water Table: 92 cm

Drainage Class: Moderately Well Drained

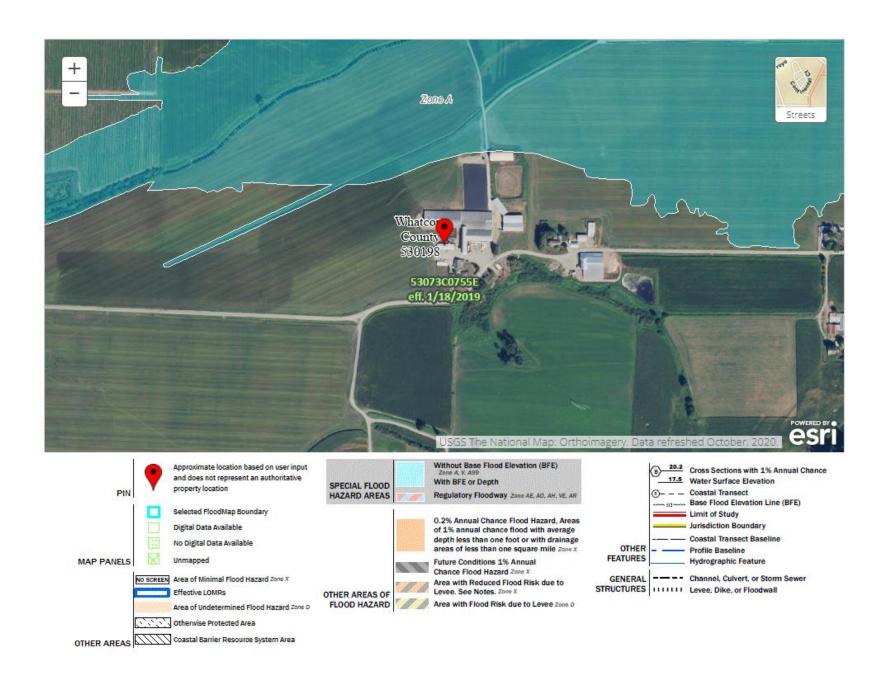
Hillview Dairy

≈ 900 feet from lagoon to Saar Creek

Depth to Water Table: 60 cm

Drainage Class: Poorly Drained

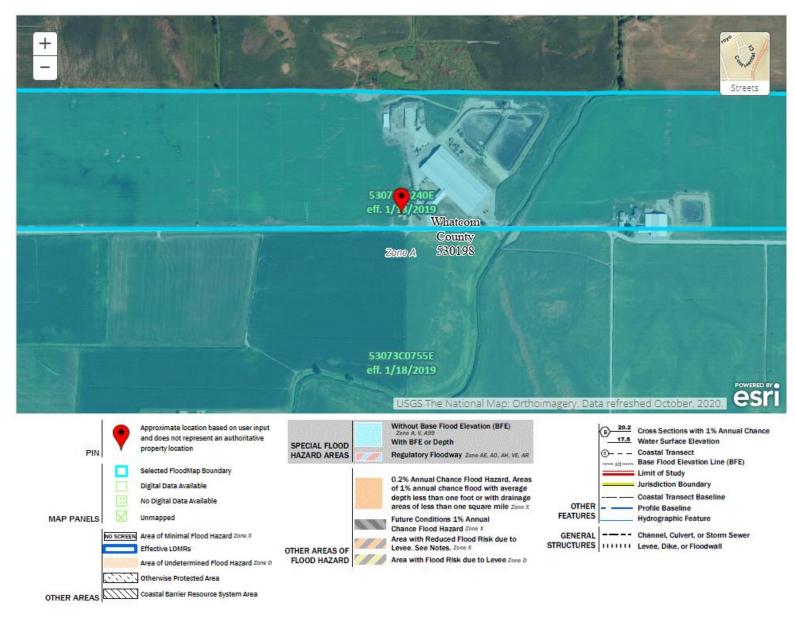
Vreugdenhil Farms LLC

5202 Jones Rd, Sumas WA \approx 200 feet from lagoons to Saar Creek

Depth to Water Table: 60 cm (Soil Mapping stops at the Canadian Border)

Drainage Class: Poorly Drained

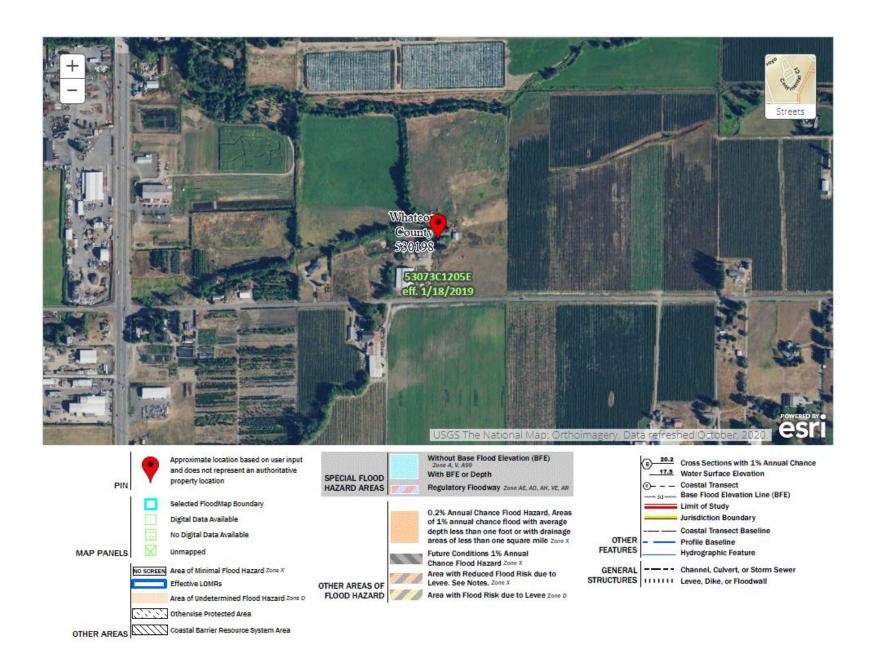
Sundstrom Family Farms

≈ 800 feet from lagoon to Tenmile Creek

Depth to Water Table: 80 cm

Drainage Class: Somewhat Poorly Drained
