STATE OF WASHINGTON  
DEPARTMENT OF ECOLOGY

**Re: No Further Action at the following Site:**

- **Site Name:** The Ostrom Co
- **Site Address:** 8322 Steilacoom Road SE, Lacey
- **Facility/Site No.:** 1386
- **Cleanup Site ID No.:** 5033
- **VCP Project No.:** SW1283

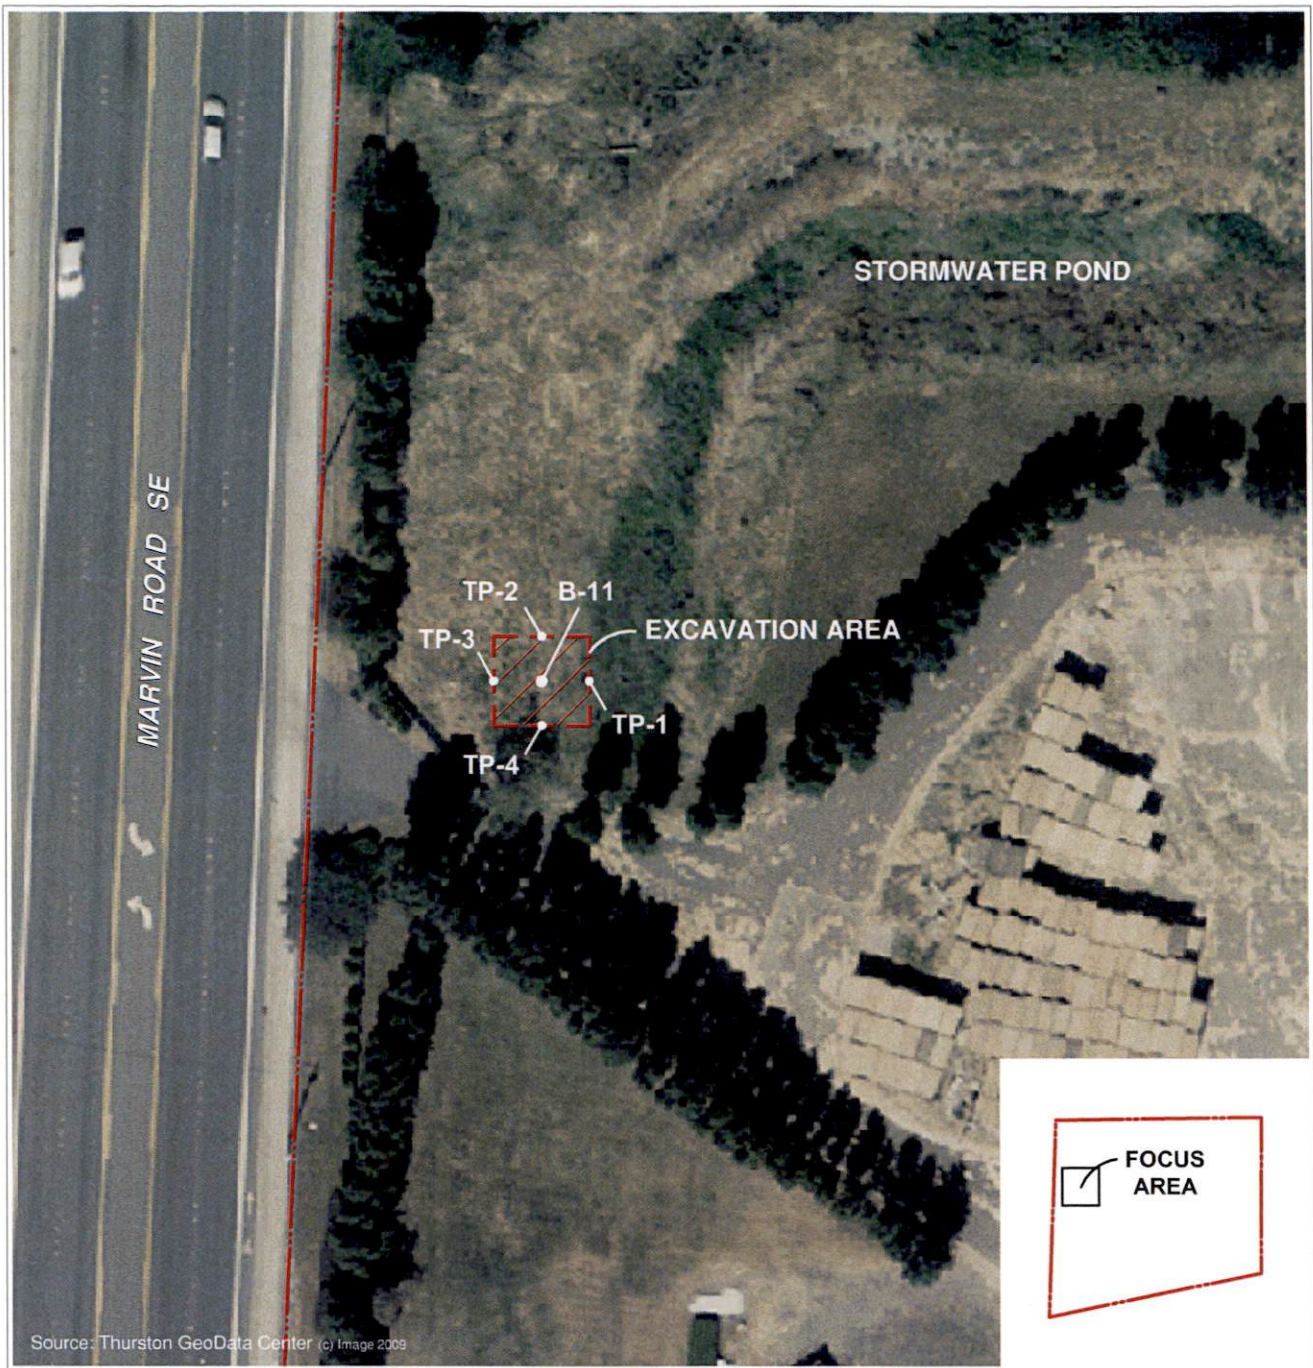
Confirmatory soil samples were collected from the base of the excavation to demonstrate that soil cleanup levels for diesel and heavy oil-range hydrocarbons had been achieved. Soil samples were collected into laboratory supplied glass jars using a stainless steel scoop from the excavation surface. The soil was packed tightly into the sample jar, then sealed, labeled and placed into an ice chest containing frozen Blue Ice for transport to the analytical laboratory. Chain of custody forms were completed in the field and accompanied the samples to the laboratory. The general sample locations are shown in Figure 2.
