Comments on Tech Note 23 Assessments for Yakima County 2015 to 2021

Friends of Toppenish Creek – August 1, 2021

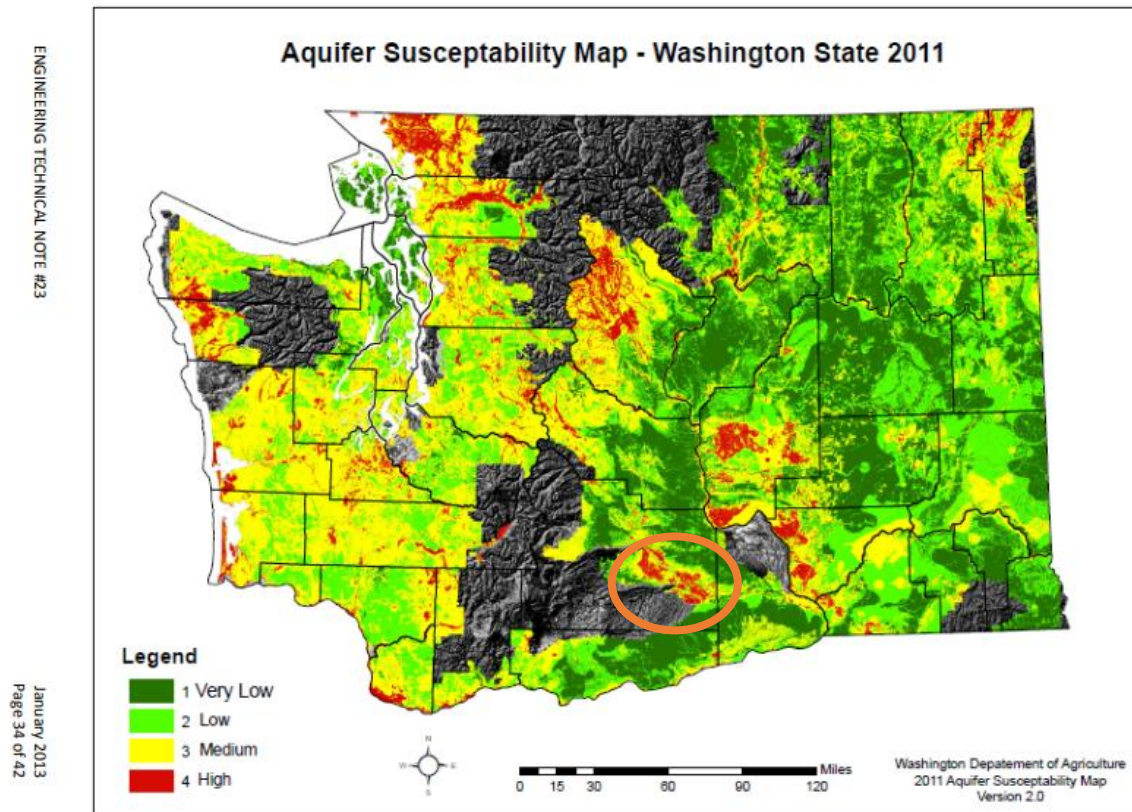
1. This is the WSDA Map that the agencies use for determining Aquifer Susceptibility to pollution from lagoons².

Much of the Lower Yakima Valley falls into the “High” category. But none of the dairies in this study had an aquifer susceptibility score greater than 3 - Medium. (See Columns U & BF) This indicates a tendency to downplay problems associated with manure lagoons.
